<b>Job Number:</b> J2201059	<b>Contractor:</b> Munro Contractors	<b>Machine:</b> 9 Ton Cat432F	<b>Date:</b> 08/03/2022
<b>Client:</b> Shire of Ashburton	<b>Location:</b> Lot 201 Onslow Road, Onslow	<b>Backhoe:</b>	<b>Logged:</b> PF
<b>Project:</b> Onslow Industrial Park		<b>Operator:</b> Colin	<b>Checked Date:</b> 13/04/2022
		<b>Bucket:</b> 600 mm wide rock	<b>Checked By:</b> TM

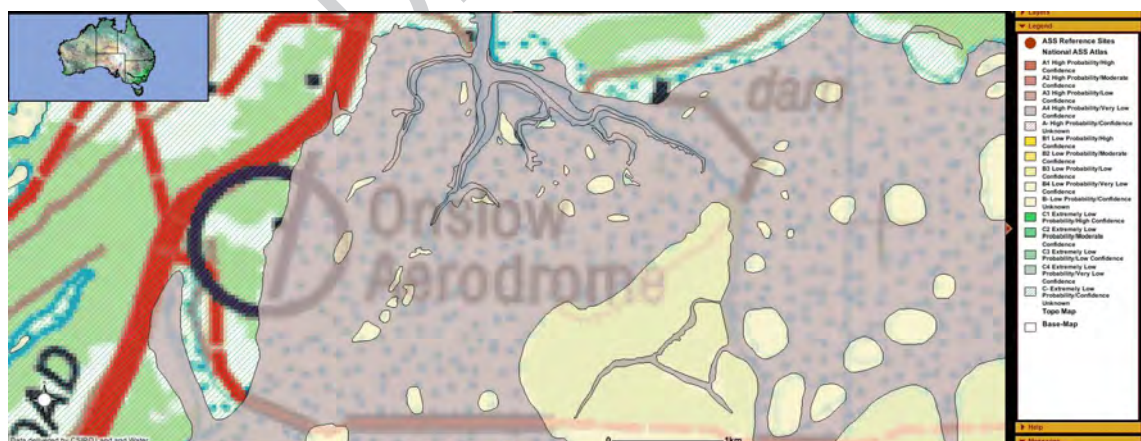
**Figure 3-2 CSIRO ASRIS mapping excerpt**
