Site Overview	Description
Surface Water Section 3.5	There are no surface water features, including drains or waterways within site. The closest surface waters are Beadon Creek (2.5 km east) and a Salt Lake (0.5 km south), located outside of the site.
Groundwater Section 3.7	<p>The site lies within the Pilbara groundwater area and Ashburton sub-area. Carnarvon superficial aquifer and the Carnarvon Birdrong artesian aquifer are present within site. Water drawn from the Birdrong Aquifer is the primary local bore water source. It is the principal artesian aquifer for the Carnarvon Artesian Basin. The Groundwater Resource Allocation Plan developed by DWER in October 2013 indicated that 1,000,000 kL/year of water were available for allocation and licencing from Ashburton – lower Cane Alluvial.</p> <p>Water level monitoring has been recorded at bores 3/97 and 4/97, located approximately 300 m to the site's southeast. The AAMGL ranged from 0.08 m AHD to 0.81 m AHD.</p> <p>The LWMS reported groundwater salinity to be less than 3,000 mg/L on average, which is considered moderately salty and suggests groundwater is unsuitable for garden bores.</p>

Rowe Group c/o Mineral Resources Limited
 Lo

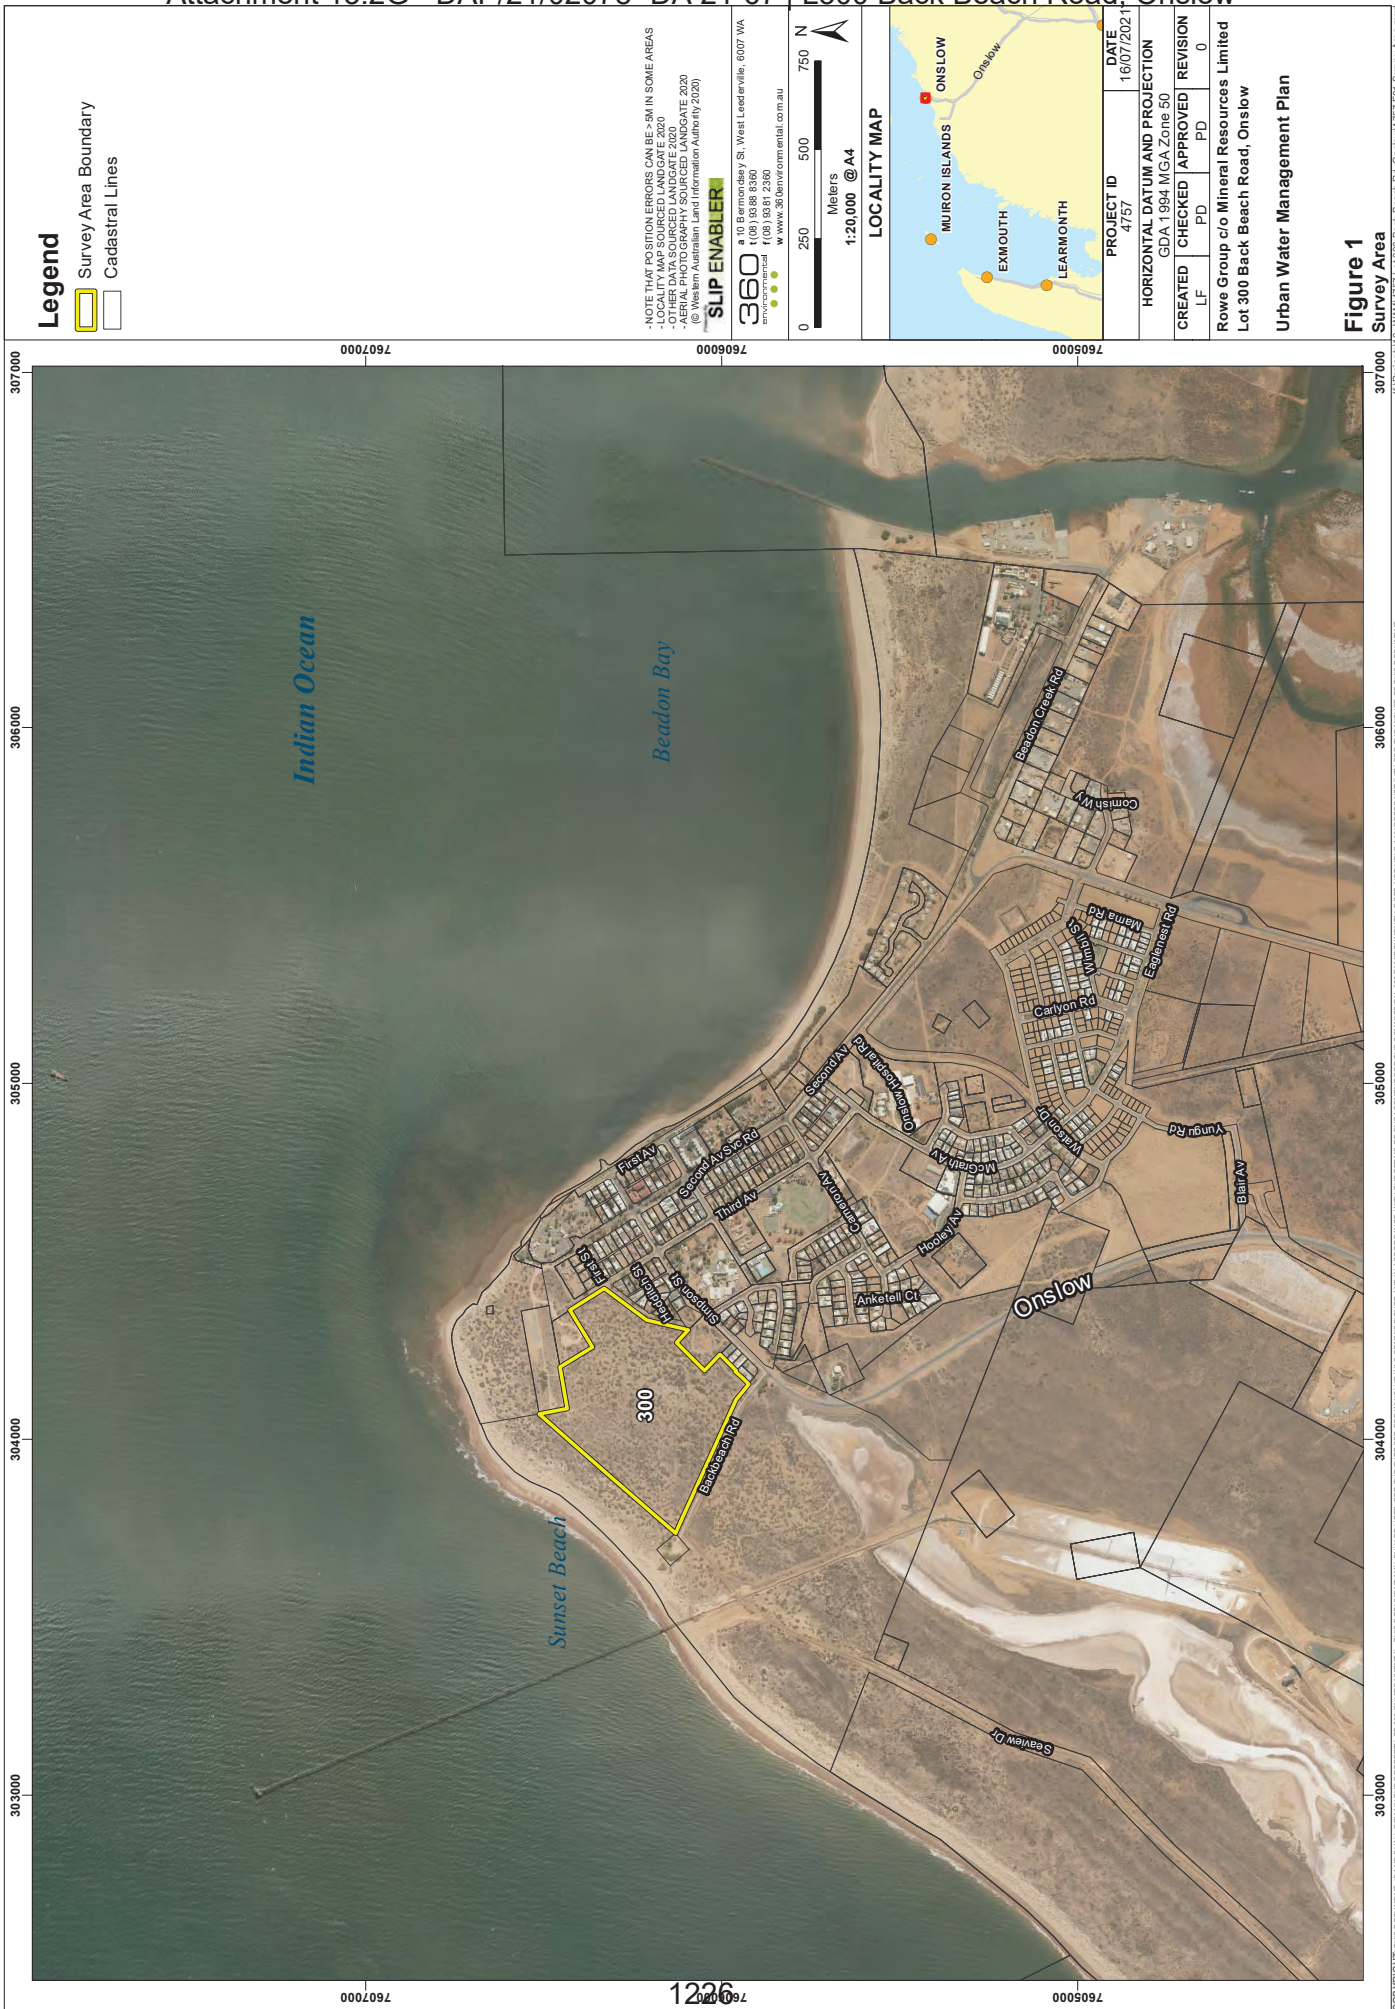
Figure 1
 Survey Area

The site is approximately 20.45 hectares (ha) and is located in the Shire of Ashburton, in Onslow. Back Beach Road bounds the site to the south and the Indian Ocean coast to the west. Residential development borders the site to the east and the Onslow Memorial Park to the north (Figure 1).

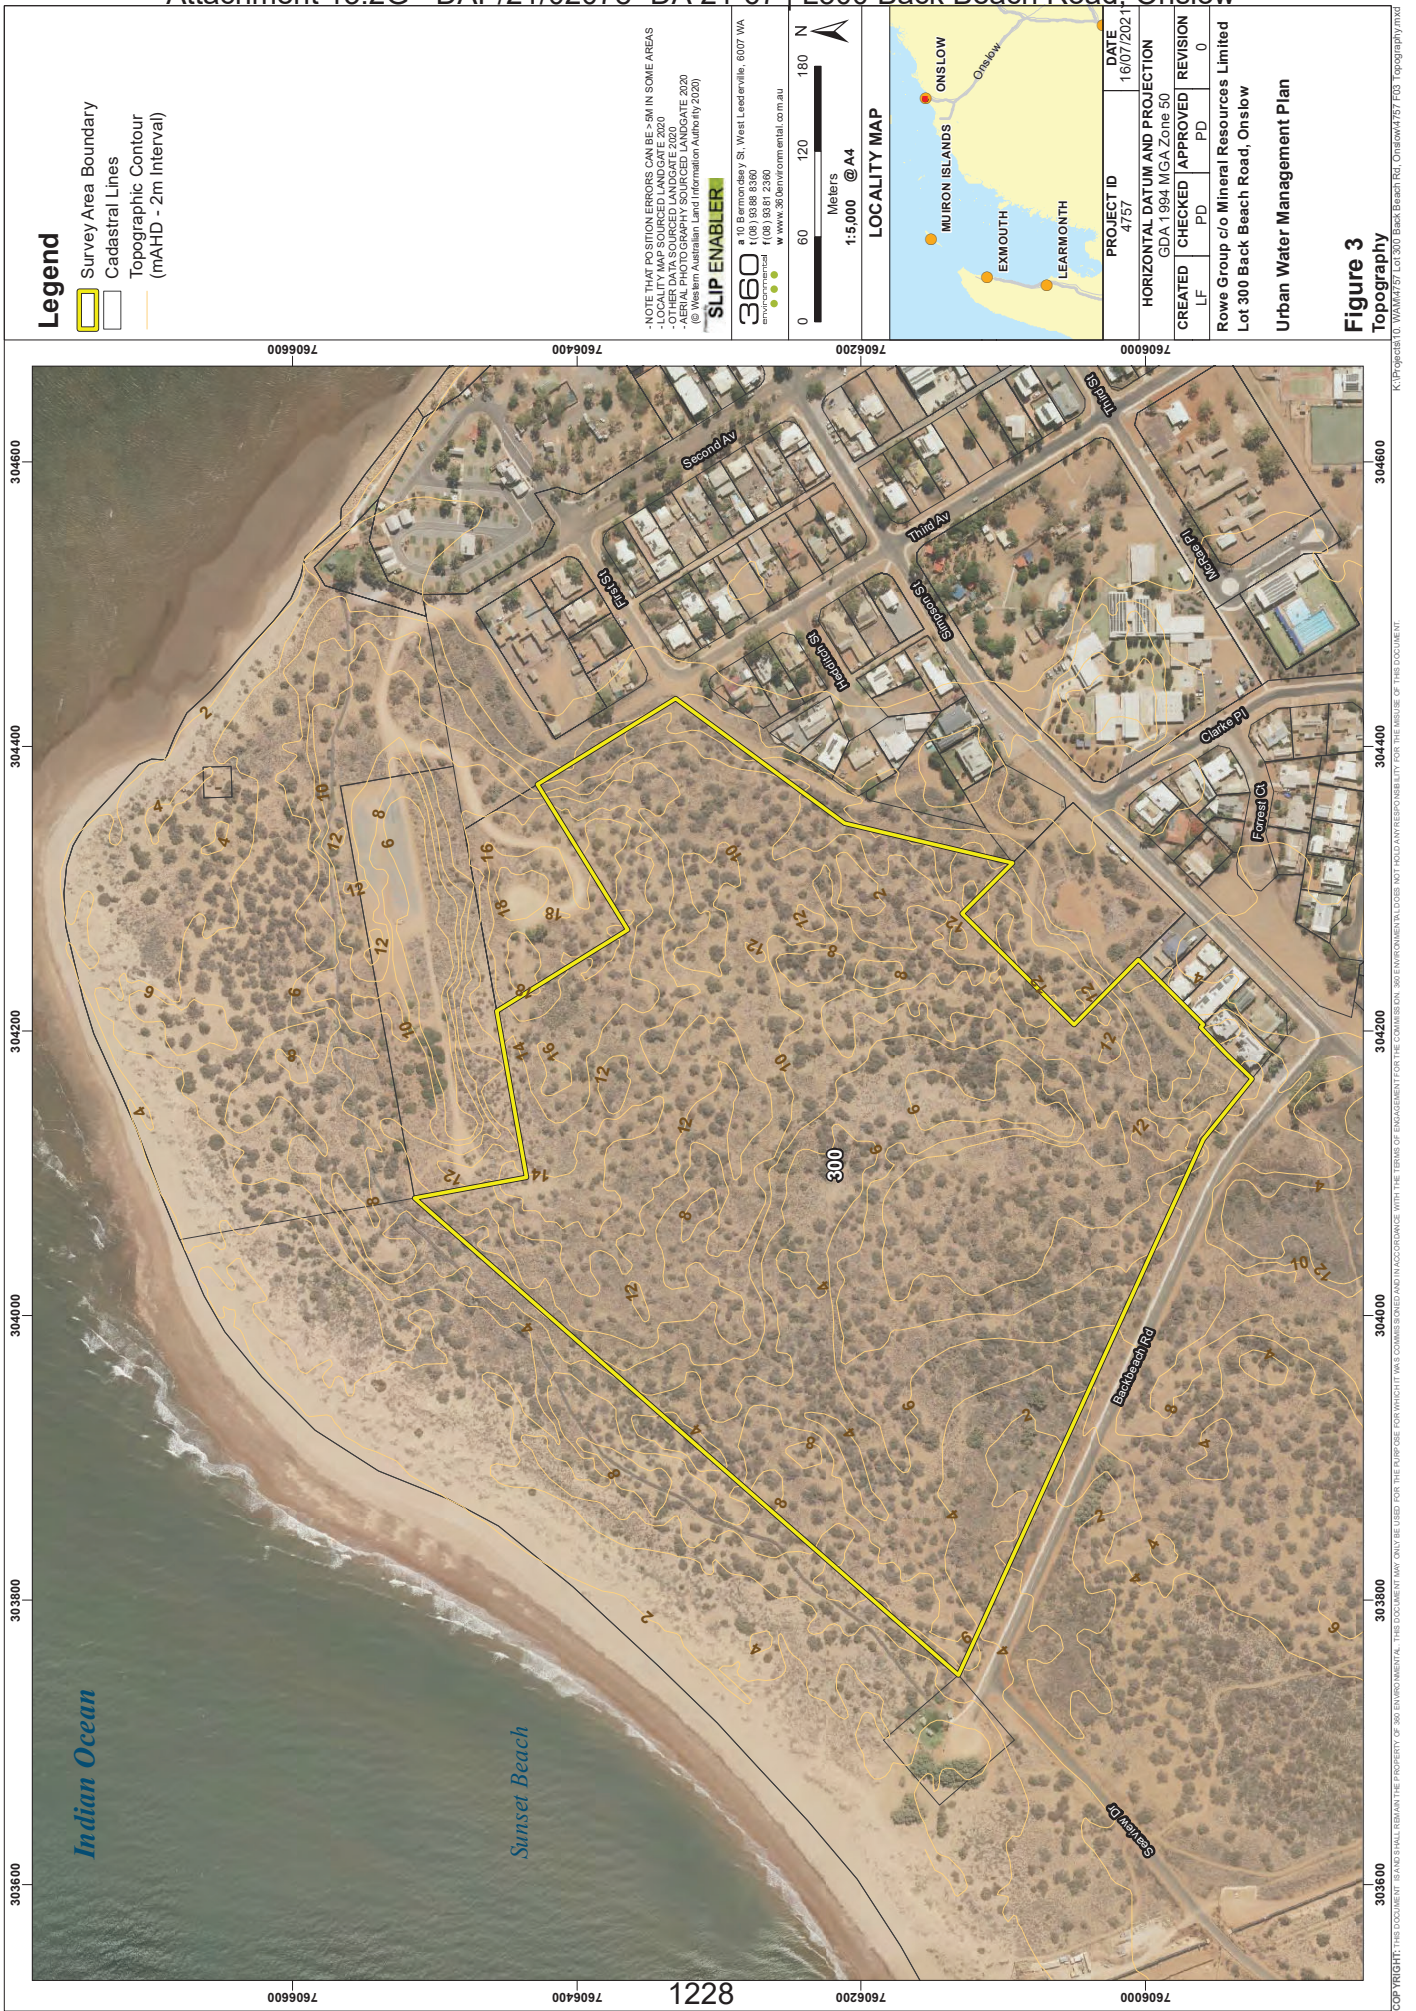
Figure 3
 Topography

Steep slopes are found to the west towards Back Beach. The site features views towards the beach. The eastern portion of the land gently slopes towards exiting housing located on Simpson Street.

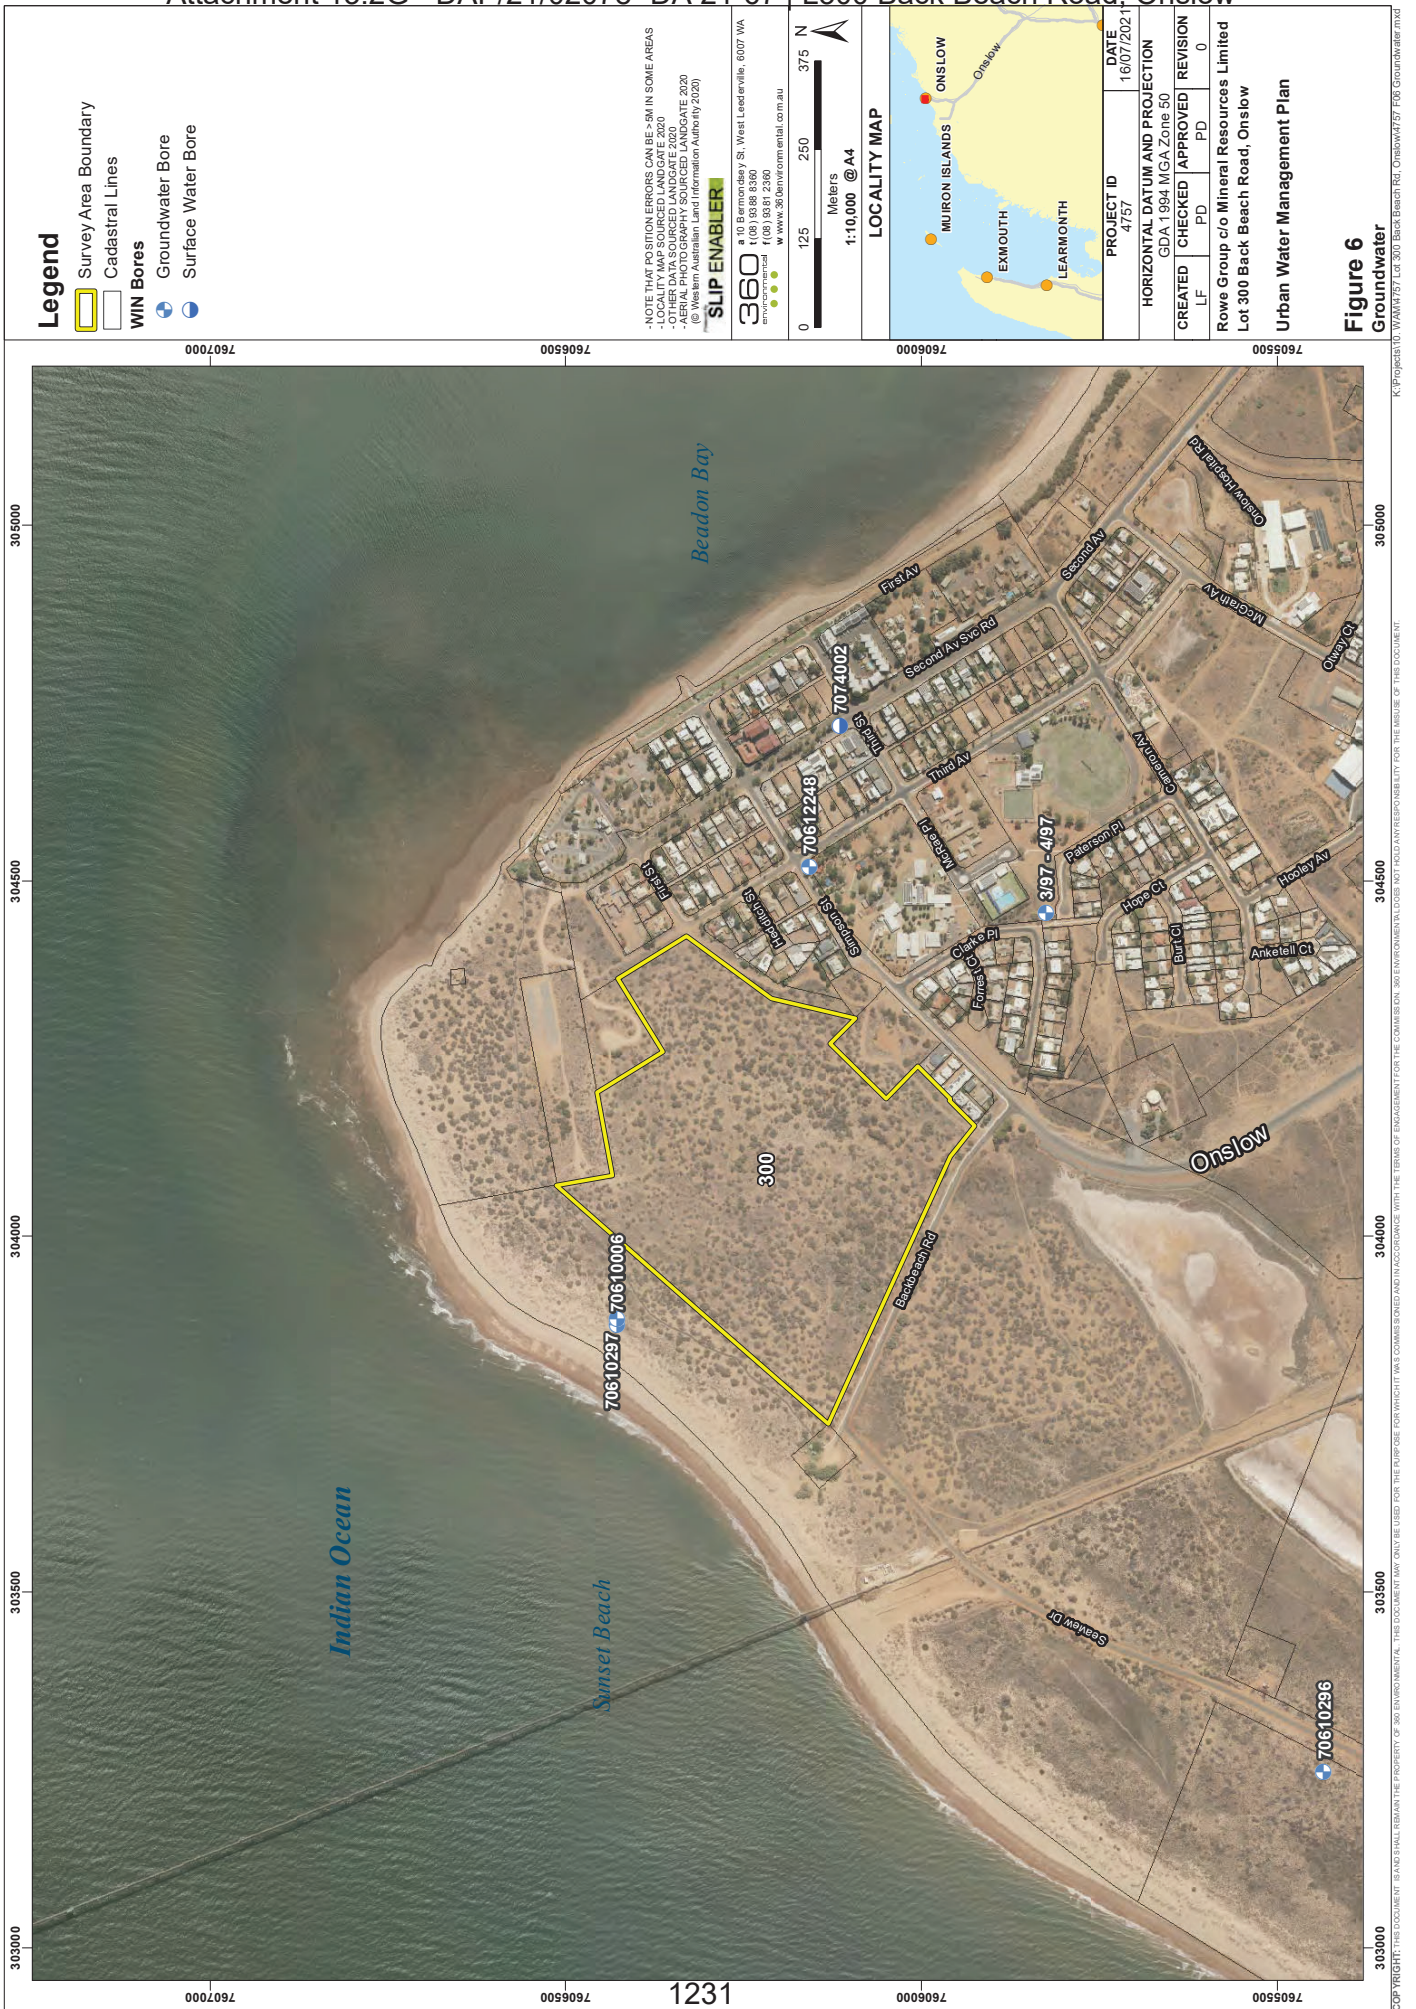
Figure 6
Groundwater

- Survey Area Boundary
- Cadastral Lines
- WIN BORES**
- + Groundwater Bore
- Surface Water Bore

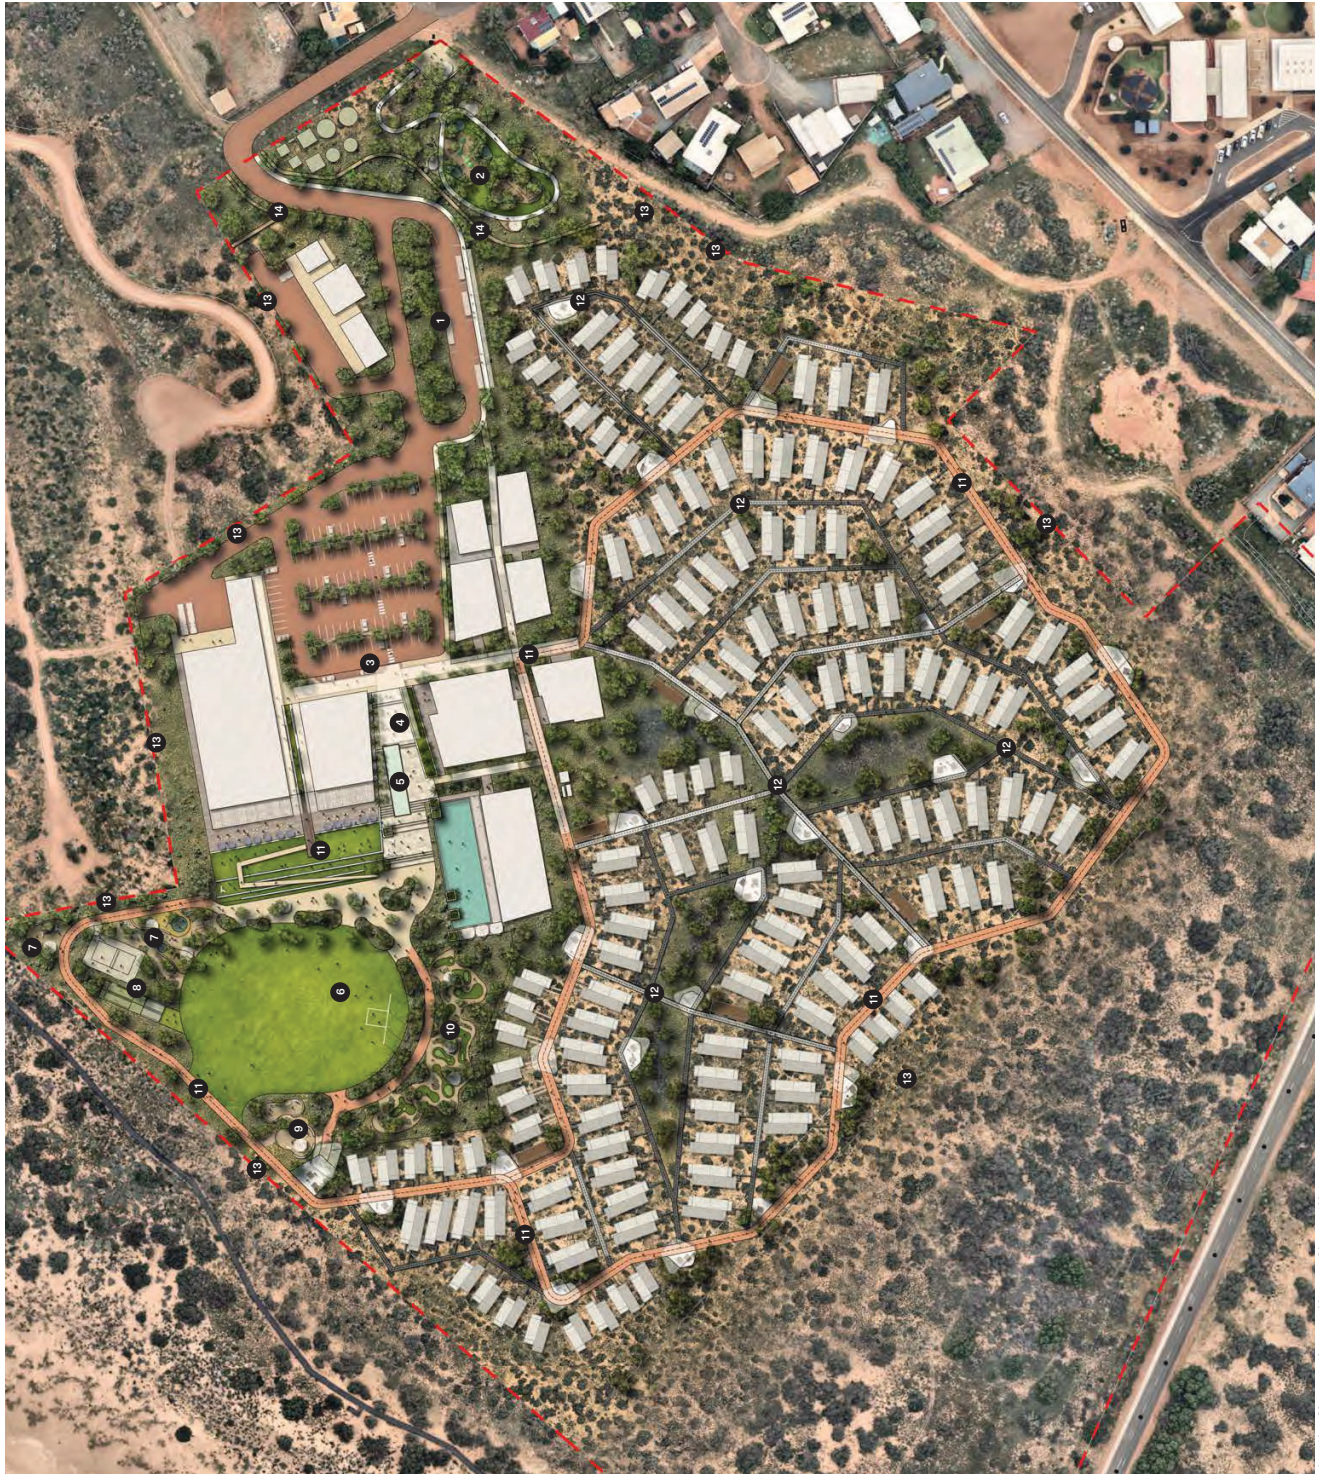
2.0 Landscape Plan

PROGRAM	
1	Bus Stand (Pickup/Dropoff)
2	Sheltered Community Playground
3	Dedicated Dropoff (Small Vehicles, Short Term)
4	Terraced Entry Plaza
5	Water Feature
6	Recreation Turf
7	Outdoor Gym
8	Cricket Nets & Beach Volley Ball
9	Relax Zone (BBQ, Hammocks, Furniture, Shade Structure)
10	Mini Golf
11	Alfresco Deck With Terraced Embankment
11	Pedestrian / Maintenance Vehicle Access (with shade structures and comfort nodes)
12	Pedestrian Access (Boardwalk with shade structures and comfort nodes)
13	Security Fence
14	Entry Statement Wall

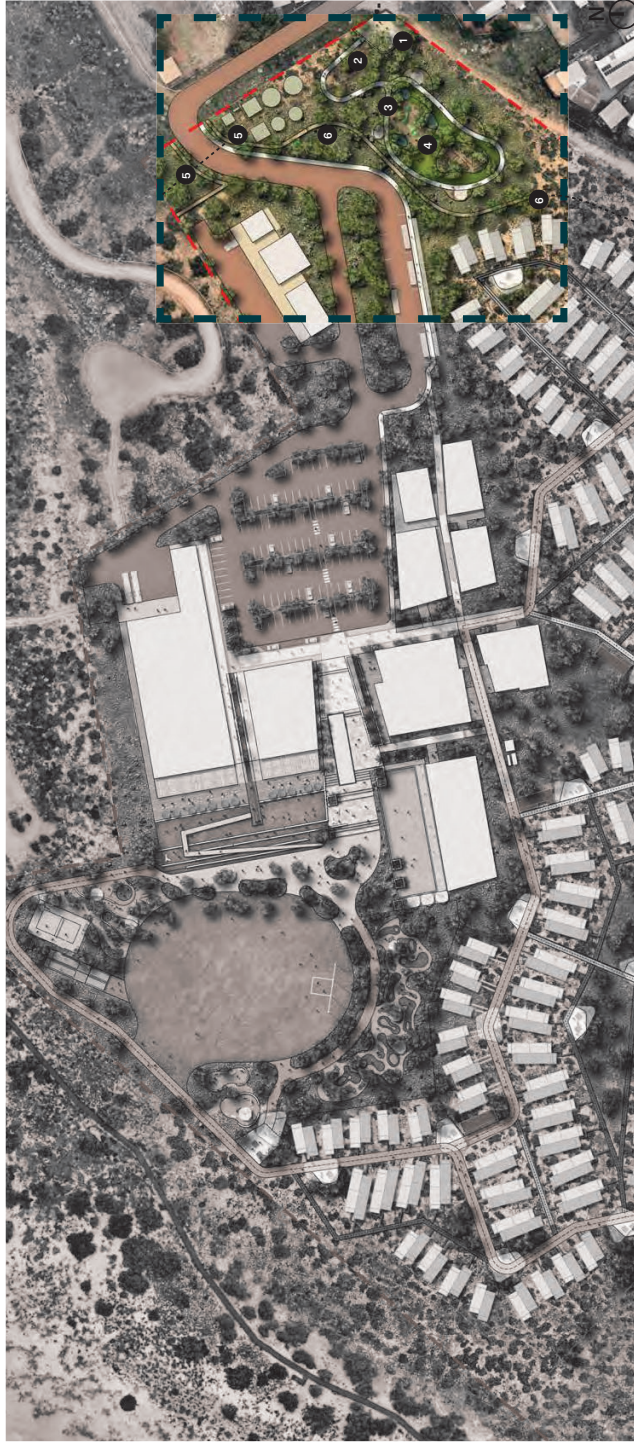
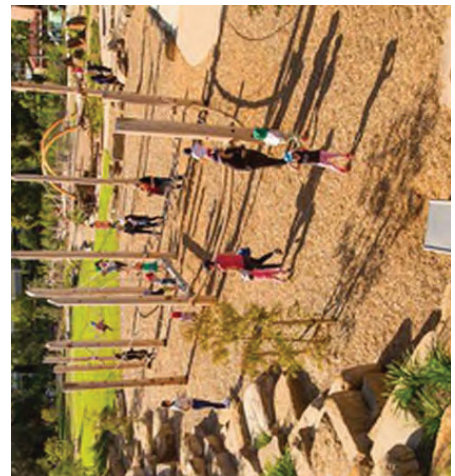
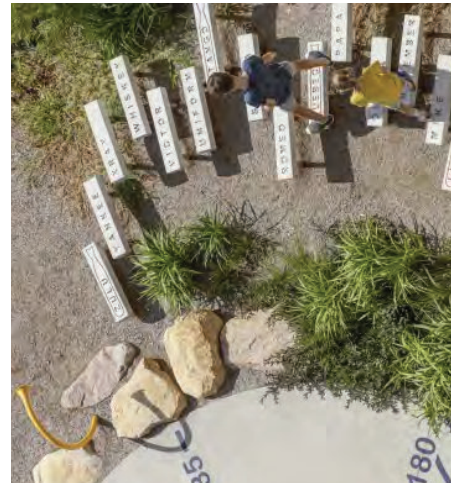
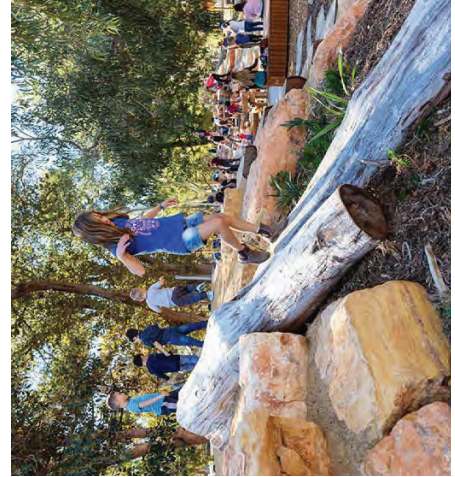
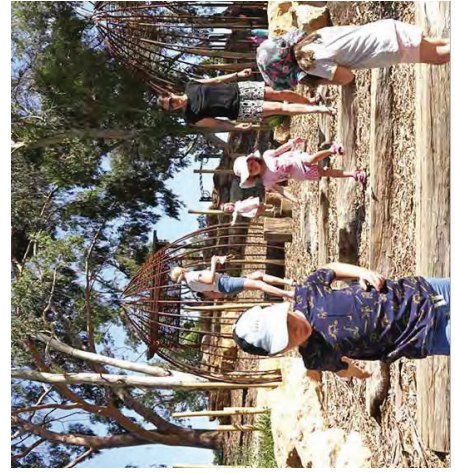
The Amenity and Recreation Areas are characterised by a mix of high quality landscape surface treatments and softscape palette that lead guests and staff through the main amenities areas. Key vistas out to the ocean are celebrated through elevated landscape terracing, alfresco areas and the entry plaza. The design of the carpark, incorporates WSUD principles to ensure large planted areas with tree planting occurs.

1	Carpark (Designed to Water Sensitive Urban Design principles)
2	Dropoff/Pickup Bays
3	Entry Plaza With Water Feature
4	Pool
5	Terraced Embankment With Universal Access
6	Alfresco Dining
7	Access To Accommodation

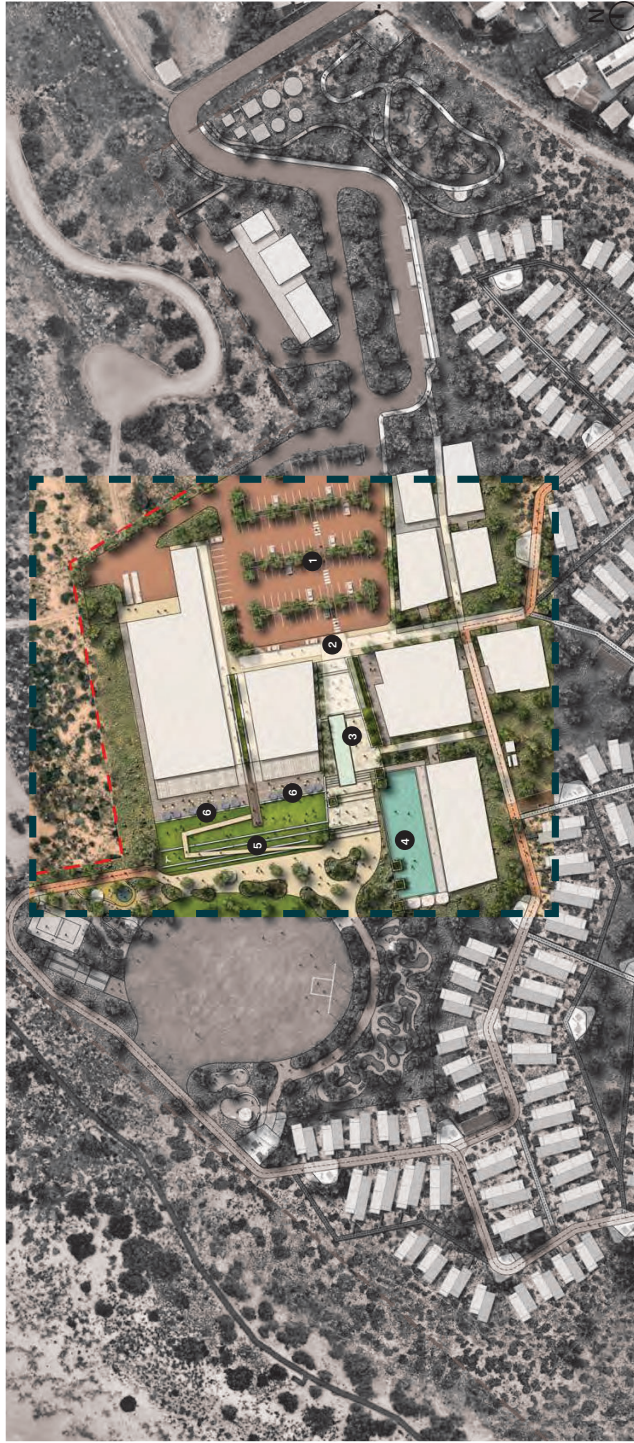
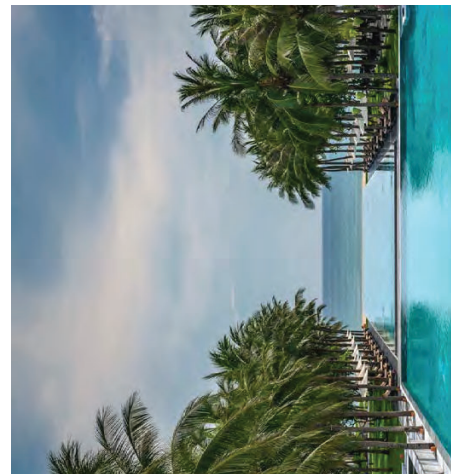
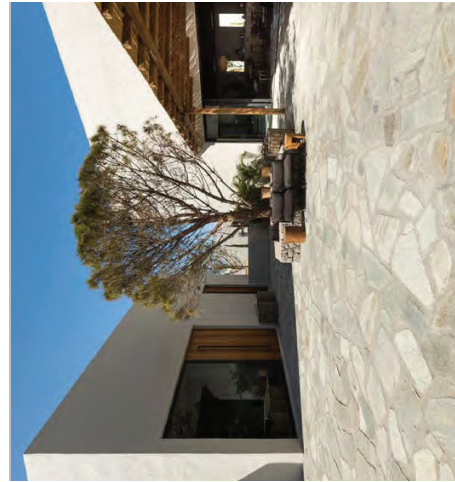
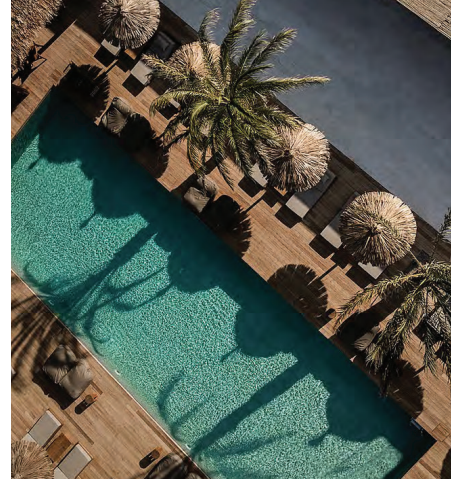
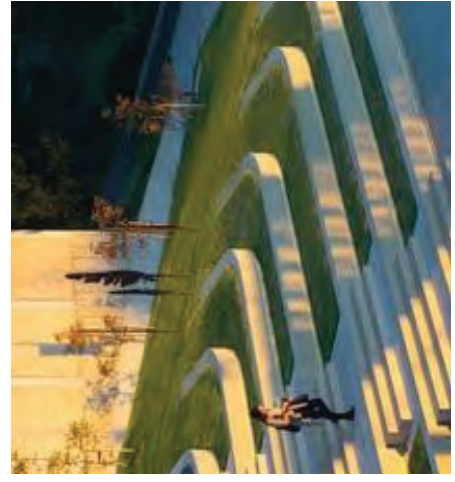
The outdoor amenities area provides guests and staff with a range of health and fitness opportunities in an outdoor setting. Universal access is provided through a network of high quality paved surfaces that link to the accommodation and administration areas.

- 1 Outdoor Gym
- 2 Beach Volley Ball
- 3 Relax Zone (including hammocks and furniture in a garden setting)
- 4 BBQ and Shade Structures
- 5 Turf Kick-About Area
- 6 Cricket Nets
- 7 Mini-Golf
- 8 Pool
