SHIRE OF ASHBURTON

SPECIAL MEETING OF COUNCIL

**AGENDA
&
ATTACHMENTS**

The use of sea water in Onslow aerodrome pavement construction

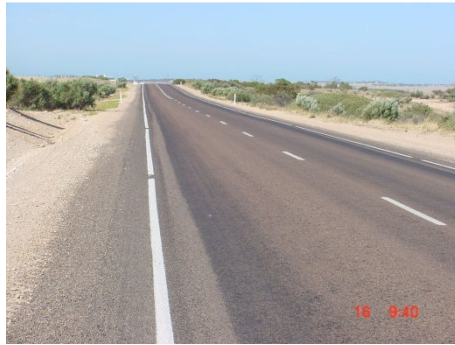
Figure 2.5: RN 2200 Flinders Highway, from MM 101.65, looking west towards Streaky Bay, 16 Jan 2003

Salt appeared to prematurely age the binder very quickly, and when the new work was inspected by the author two months after construction, the binder condition was rated as 'poor'. However, the seal was still functioning well at this stage (Figure 2.5 where RN is the Department of Transport Road Number, and MM is the maintenance marker, giving site location in km with zero commencing at the northern end of the highway).

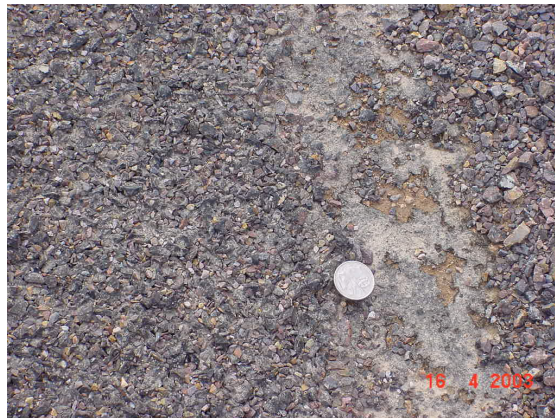
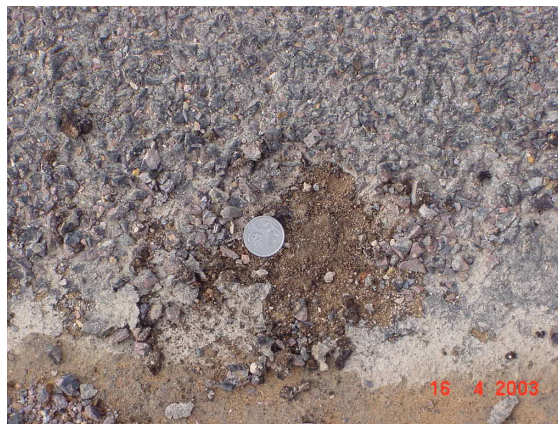
Figure 2.6: Salt damage on shoulder widening constructed with full depth sea water, 5 months old

However, the fresh binder continued to undergo rapid aging and soon started flaking from the surface, as shown in Figure 2.6.

At five months this damage was not serious enough to warrant rework, but monitoring ceased when the author relocated his employment interstate.

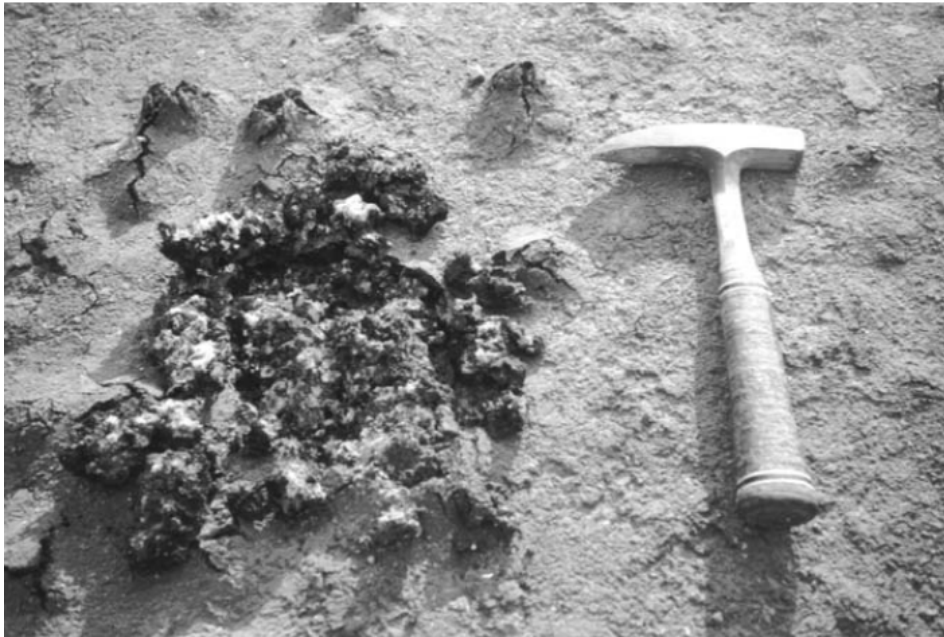
Figure 2.7: Volcano blisters and salt in loosened primed base

The formation was constructed using brine water with a total dissolved solids (TDS, another term for TSS) content of 4% to 15%. Due to a shortage of fresh water, the brine was also used for the subbase. Fresh water was however used for the basecourse. Construction progress suffered several delays in 1989. By July 1990 significant failures occurred, as shown in Figure 2.7 and Figure 2.8.

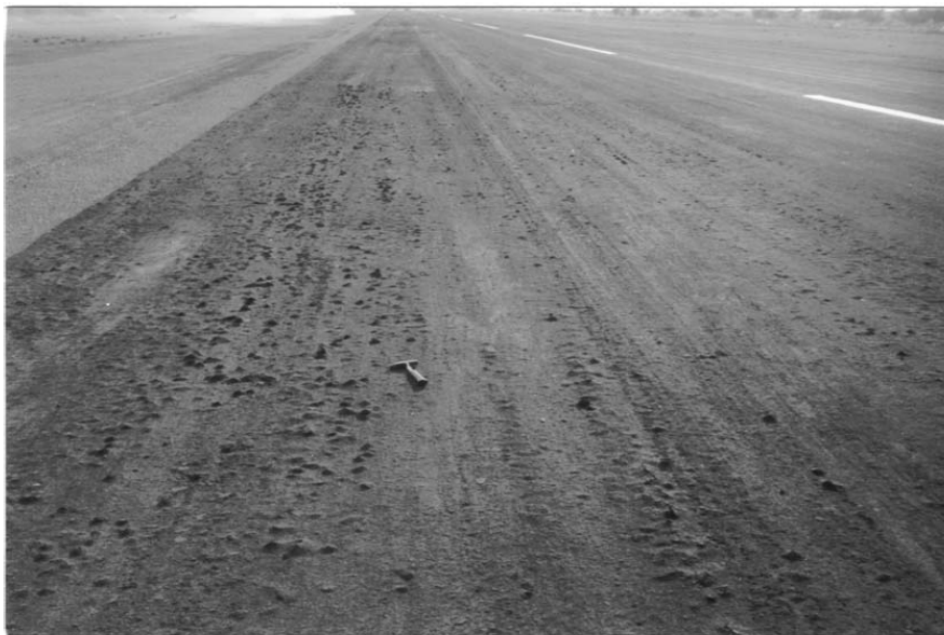
Figure 2.8: Salt blistering

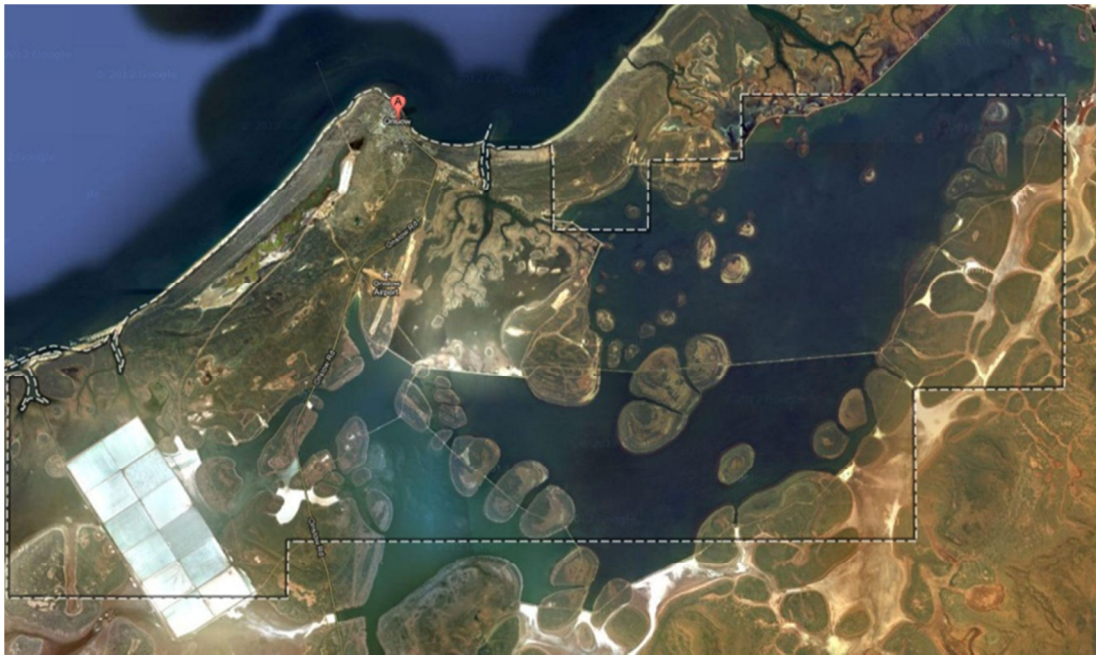
Figure 3.2: Aerial view of Onslow aerodrome area showing extent of salt pan

The aerodrome is located in an area that may be described as a salt pan. This is replenished with sea water from a number of inlets, the closest to the site being Beadon Creek. There is also a commercial salt farm nearby. (Figure 3.2).

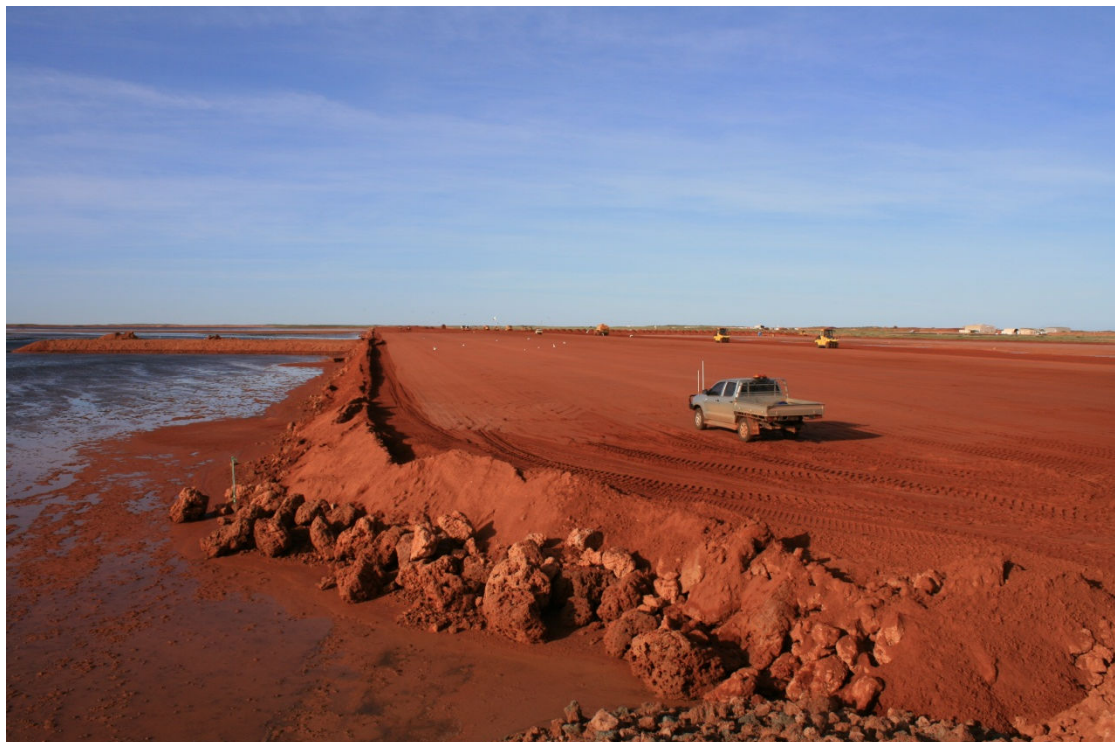
Figure 3.3: Proximity of sea water to the runway earthworks

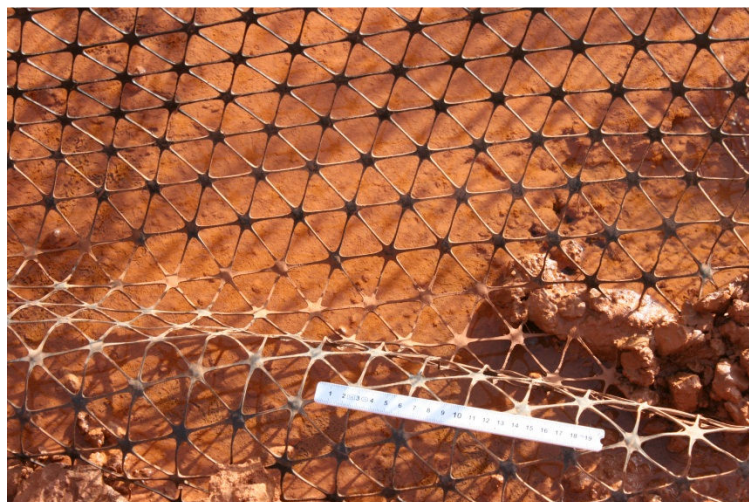
Figure 3.5: Tri-axle geogrid placed over natural surface prior to placement of select fill

A variation to the original design was the addition of a TX 160 tri-axle geogrid to the natural surface, prior to the placement of the select fill formation. This can be seen in Figure 3.5 (where the sea water is also seen co-existing at natural surface level).

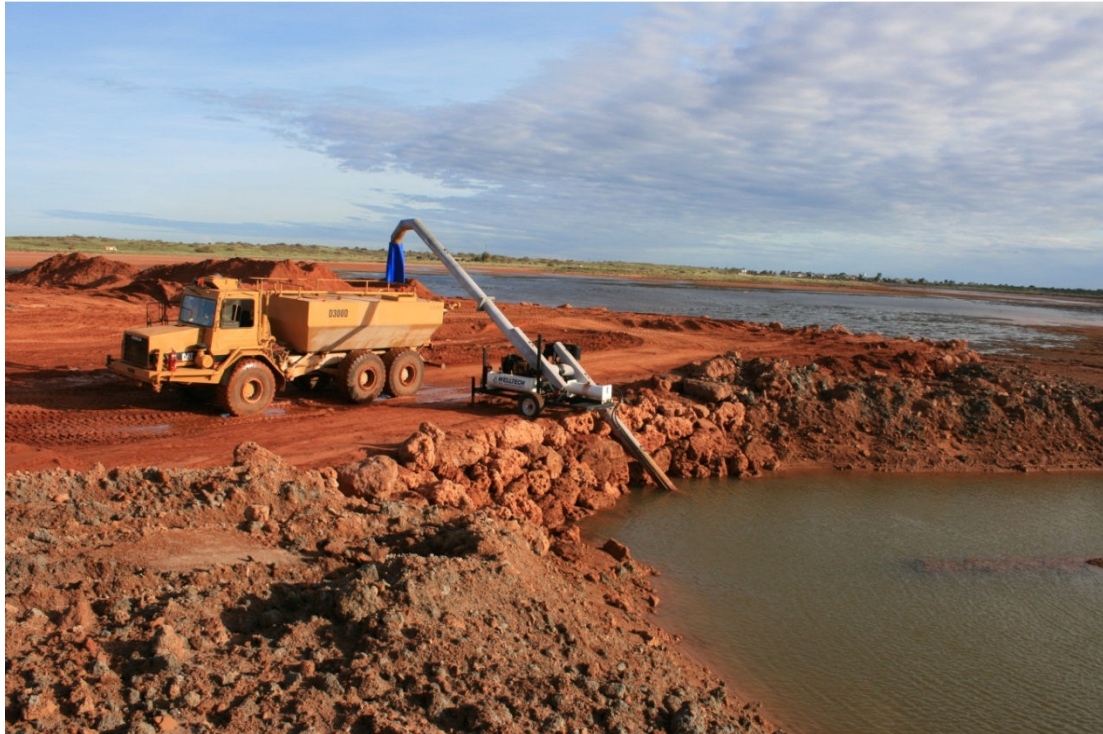
Figure 3.6: Sea water for compaction is extracted from adjacent to the earthworks

Construction of the select fill formation was then observed, with sea water being used for the compaction water. It is extracted as per Figure 3.6, and can be sprayed directly on to the formation as per Figure 3.7

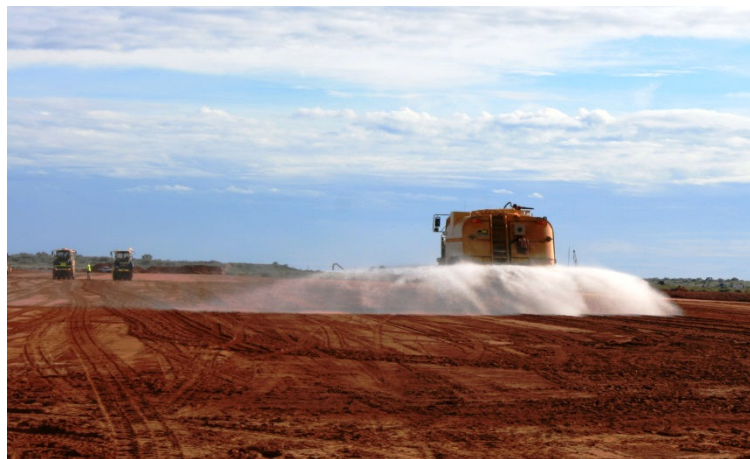
Figure 3.7: Sea water applied to formation works

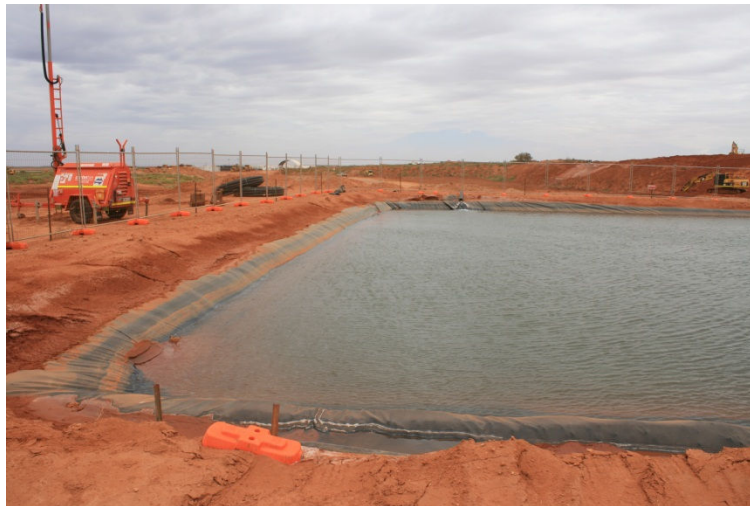
Figure 3.8: Seawater stored at the 'turkeys nest'

Sea water is also transported to a central storage called the 'turkeys nest' (Figure 3.8), where it can be irrigated onto the select fill overnight (Figure 3.9), thus pre-wetting fill to around 5% moisture content prior to transportation to the runway construction site. Once there, more sea water is added until it reaches optimum moisture content (OMC) of around 6½ - 7%.

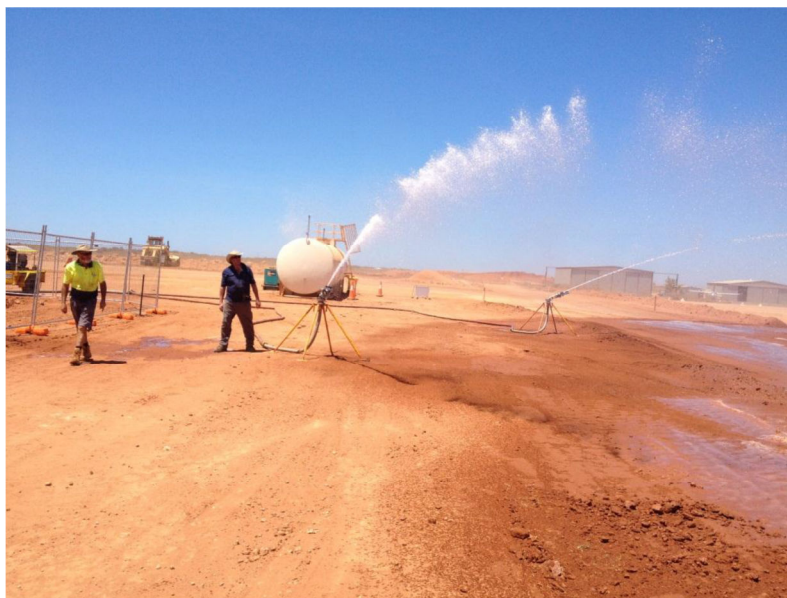
Figure 3.9: Sprinklers set up near the turkeys nest to pre-condition the select fill

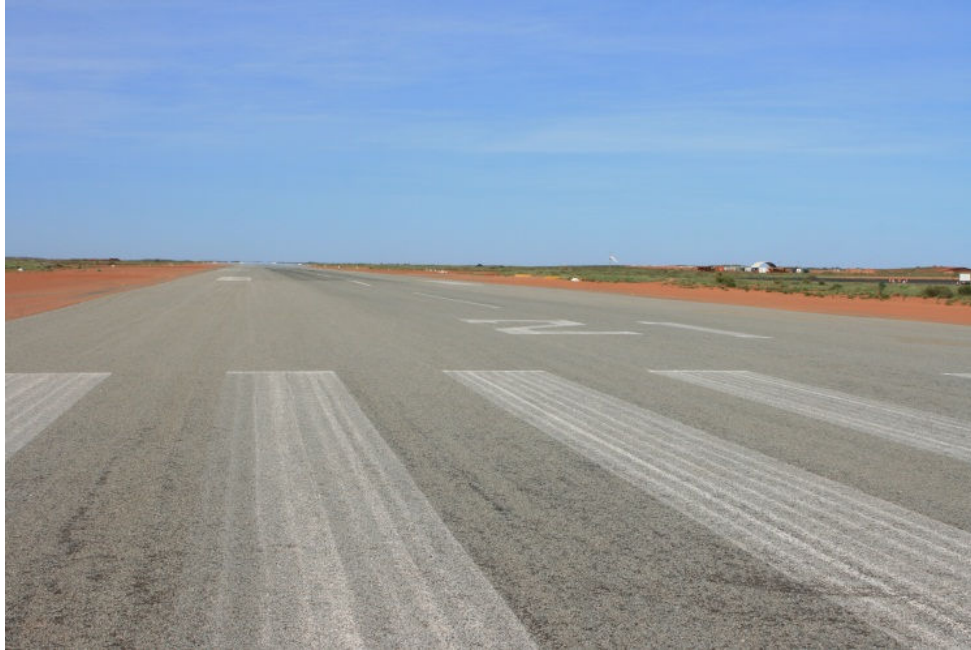
Figure 3.10: Existing runway 03/21, at the 21 end

Discussions with Shire staff indicate this pavement was constructed using fresh water. Even so, salt damage is still present in the form of blistering, and the mitigation approach adopted is to roll periodically with a pneumatic multi-tyred roller. The spray seal could be a single seal, rather than the more usual airfield double or triple seal.

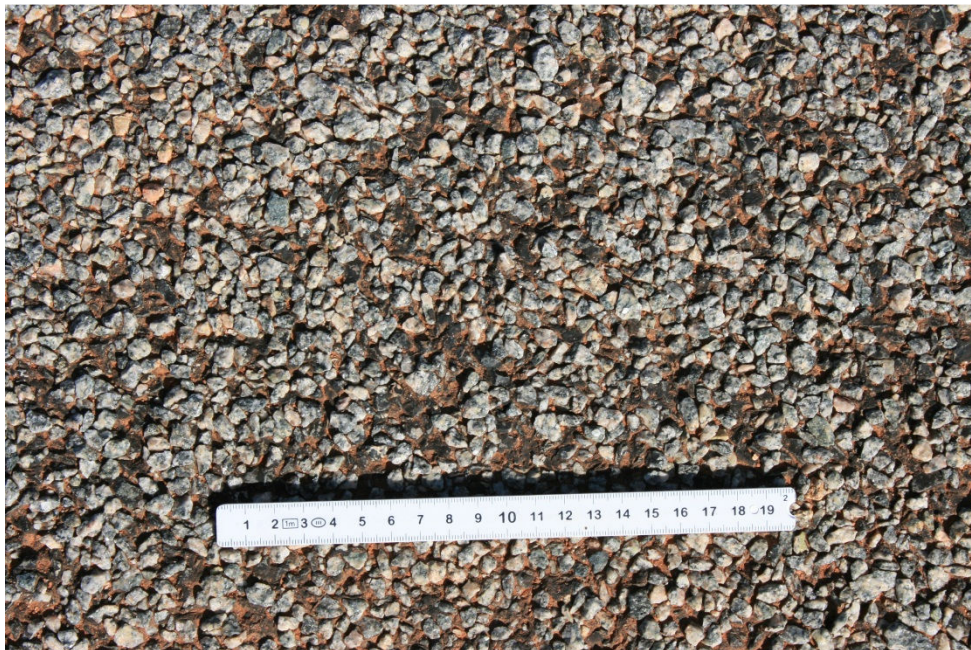
Figure 3.11: Sprayed seal on existing runway

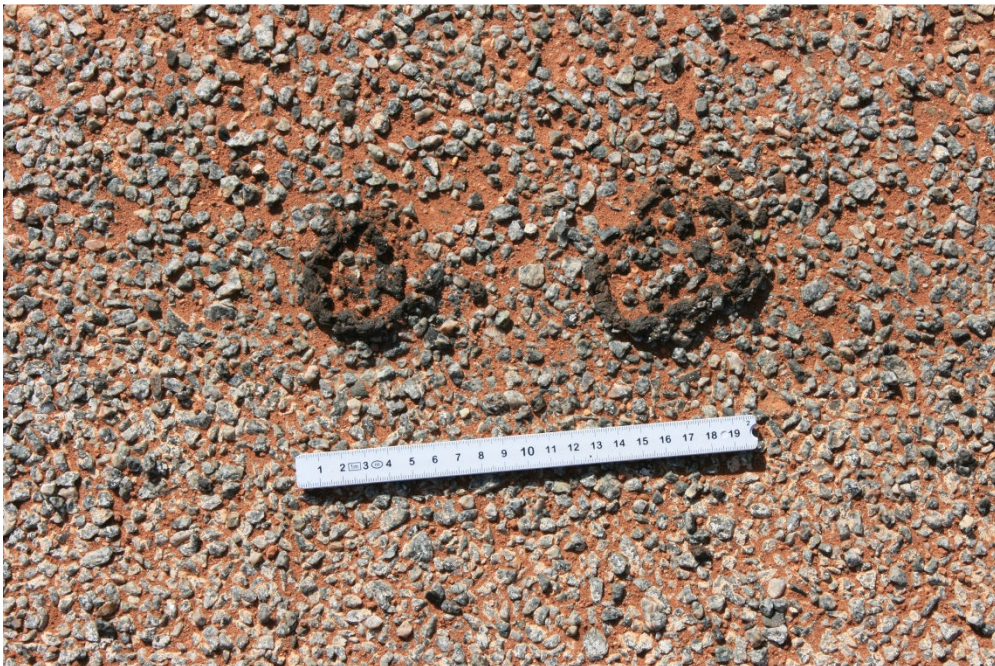
Figure 3.12: Salt damage on existing runway

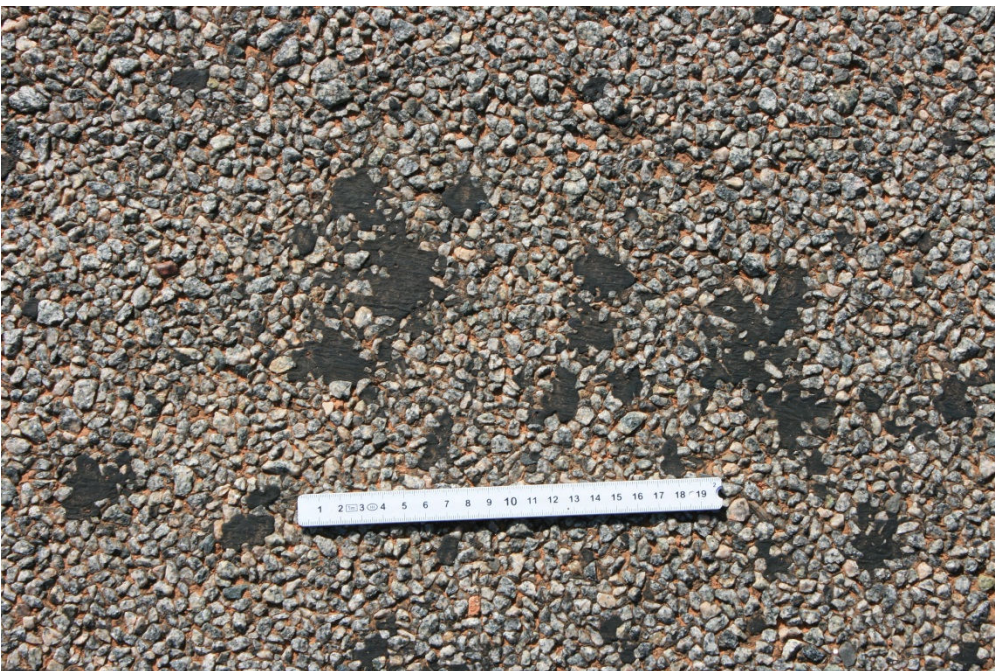
Figure 3.13: Apparent salt damage mitigated by pneumatic tyred rolling

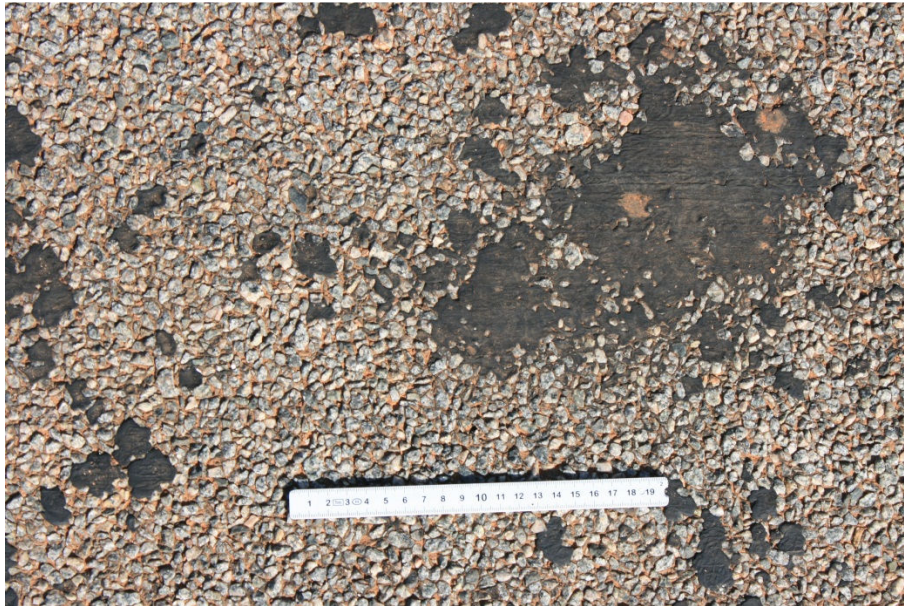
Figure 3.14: Apparent salt damage mitigated by pneumatic tyred rolling

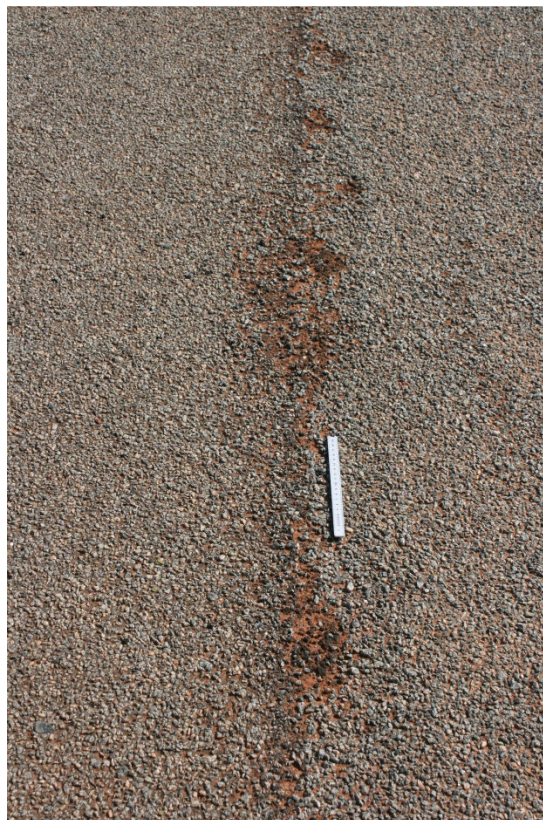
Figure 3.15: Salt damage

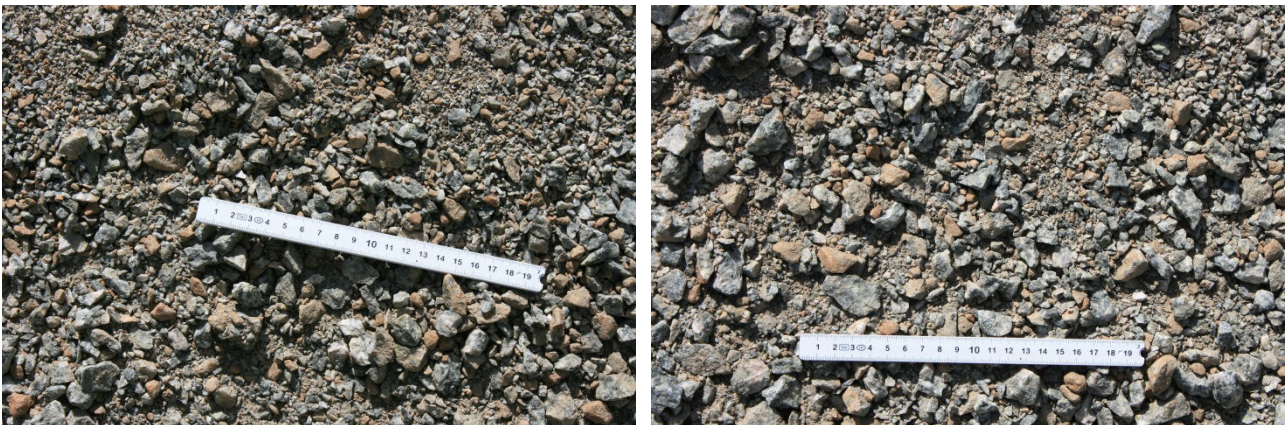
Figure 3.16: Basecourse material (loose)

At a site inspection of the quarry on 26/02/13, the material appeared to be of a very good quality (Figure 3.16 and Figure 3.17). A 20 kg sample of the basecourse material was collected for future laboratory testing for adhesion compatibility with various bitumen emulsion products.

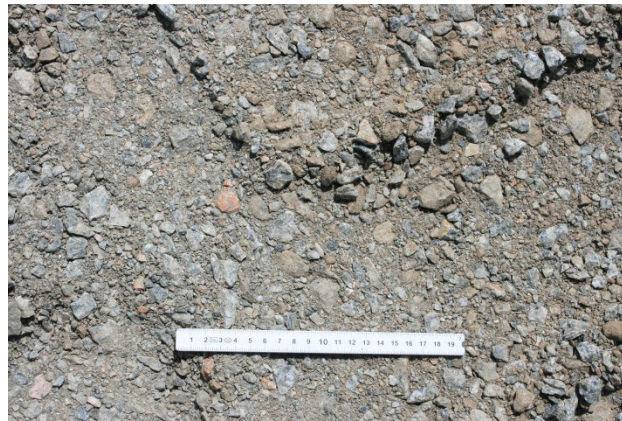
Figure 3.17: Basecourse material (compacted under the tyre of a front end loader)

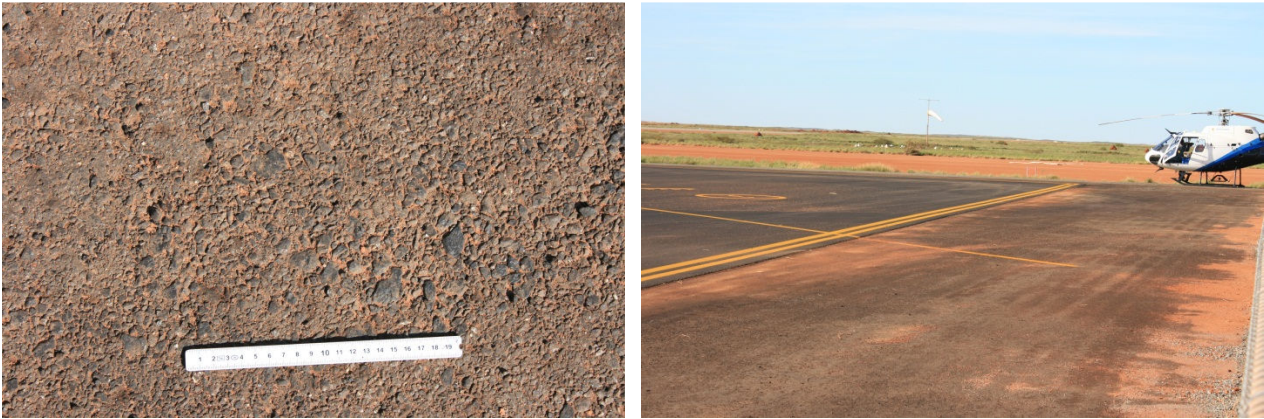
Figure 3.19: Site trial of basecourse material compacted with sea water, primed and asphalted

It was very interesting to see a trial of the basecourse material compacted with sea water, primed, and surfaced (Figure 3.19). This was at a temporary apron extension as part of a cyclone evacuation risk management measure, and will be removed when this aerodrome project is completed.

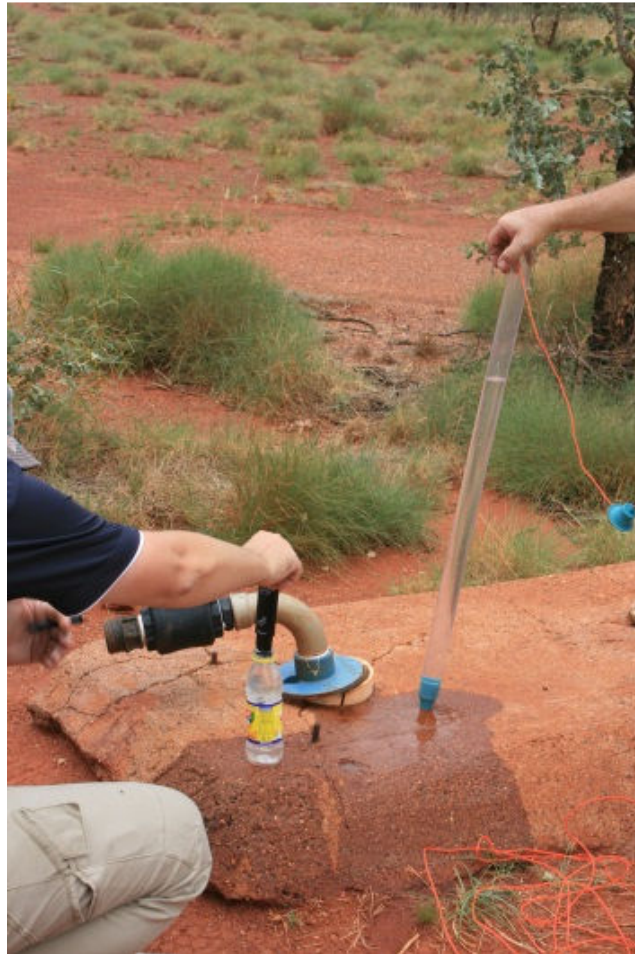
Figure 3.20: Field sampling and testing of bore water

The bore water closest to the quarry (i.e. 60 km from site) was sampled by Shire staff and tested during the site inspection, but the salinity was beyond the range of the test instrument to hand. This meant that the *Botswana Taste Test* (Obika 2001, page 27) had to be implemented. The water tasted to be about as salty as sea water, and with a sharp, tangy taste. Further sampling was postponed until a different test instrument could be obtained.

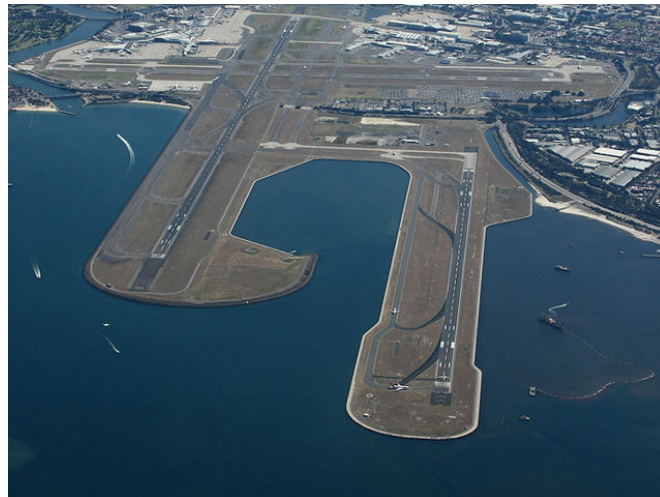
Figure 5.1: Sydney Airport parallel runways

For a comparison, Sydney airport also has runways built close to seawater, as shown in Figure 5.1. Could any knowledge be gained from this?

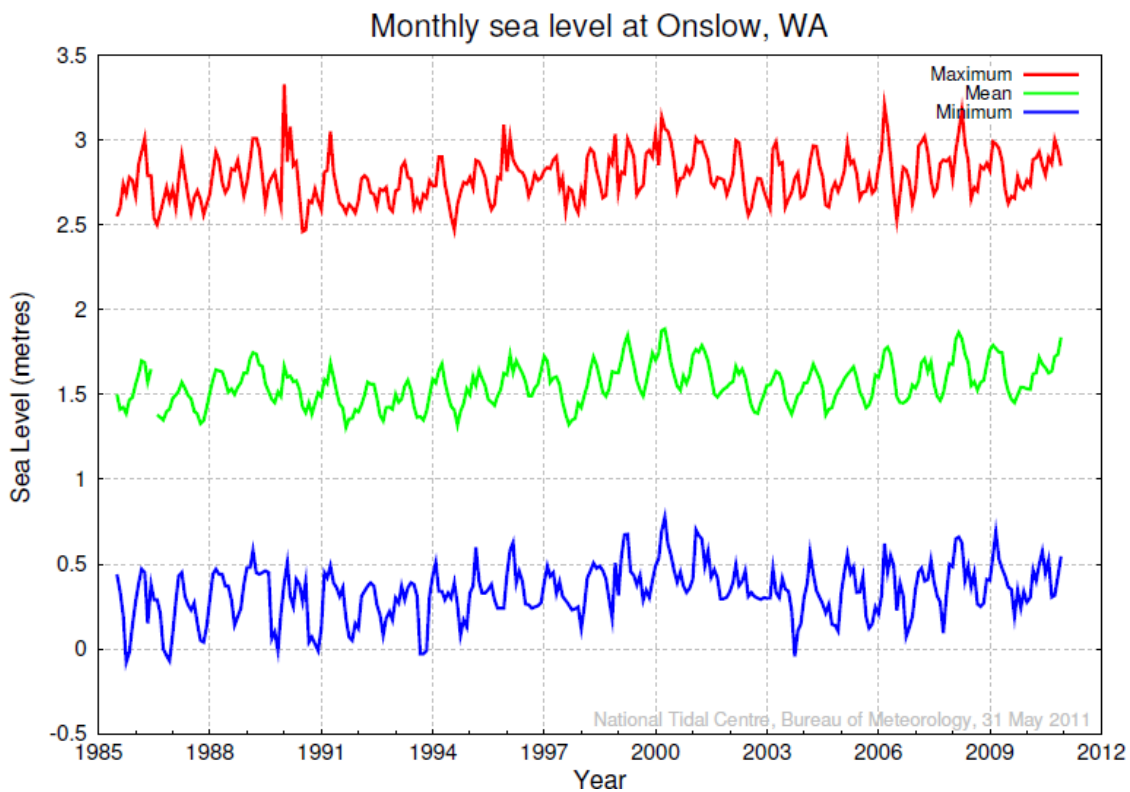
Figure A.1: Onslow sea levels for period 1985 to 2010

Standard deviation of the observations = 0.5444 metres

Skewness = 0.0446
